**Repair of Partially Penetrated Weld Joints in Copper-Nickel
Seawater Piping on Naval Ships**

Submitted to the Department of Ocean Engineering and the
Department of Materials Science and Engineering
in Partial Fulfillment of the Requirements for the Degrees of
Master of Science in Naval Architecture and Marine Engineering
and
Master of Science in Materials Science and Engineering

September 2000

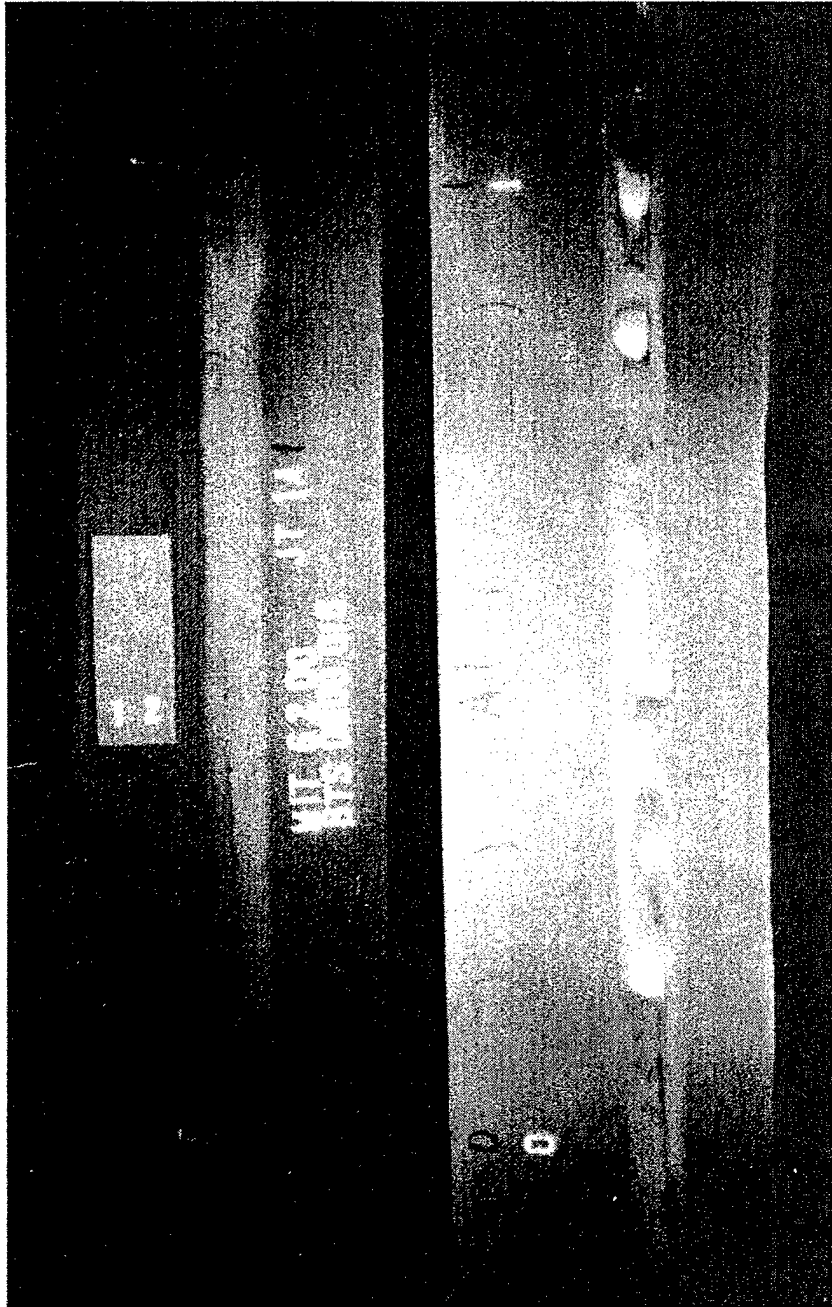
The figures on the next several pages show X-rays of all the joints. Small dark spots are pores, larger dark patches are thin patches, usually due to concavity, dark lines are partially penetrated seams. Figures 4-1 through 4-12 show the original condition of the weld on the left and the condition after welding on the right. The numerals 0, 1 and 2 are indices around the circumference; the index 3 on the right of Figures 4-10 and 4-12 is equivalent to the index 0 on the left. Weld C1 is on the left of Figure 4-13, C2-A is in the center, C2-B is on the right. Figure 4-14 shows welds C3-A, C3-B and C3-C from left to right. Welds D and C in Figure 4-15 are continuations of welds C4-A and C4-B, respectfully, from top to bottom. The four vertical welds in Figure 4-16 are welds C5-A, C5-C, C5-D and C5-B from left to right; weld C5-E runs horizontally across the bottom. Figures 4-17 and 4-18 use circumferential indices 0,

Figure 4-1: Weld A1, Section 0-1

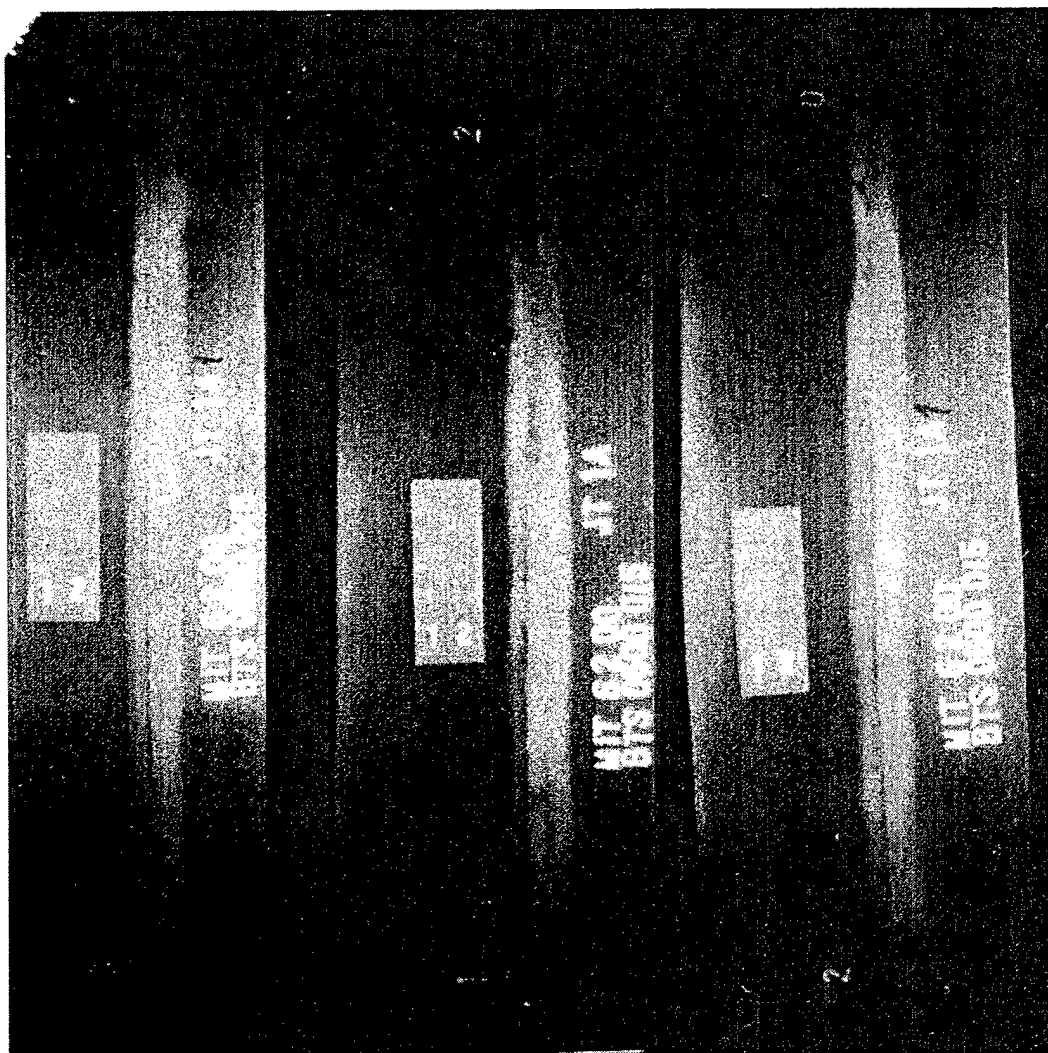
Figure A-1: Weld A1 Before Repair
